6982 S. Schomberg RD Cedar, MI 49621

HISTORIC BUILDING RESTORATION

Holy Rosary Church

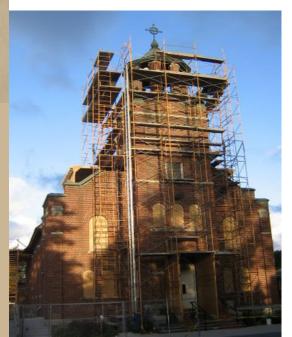
Extensive scaffolding was required to access the bell tower masonry. The bell tower masonry above the main roof was partly rebuilt and completely repointed, and the damaged limestone was replaced. Good access permitted us to "babysit" the lime mortar as it hardened.
